April 30, 2004

Site Inspection, Quality Building Stone, Red Chief Mine,

S/015/083, Emery County, Utah

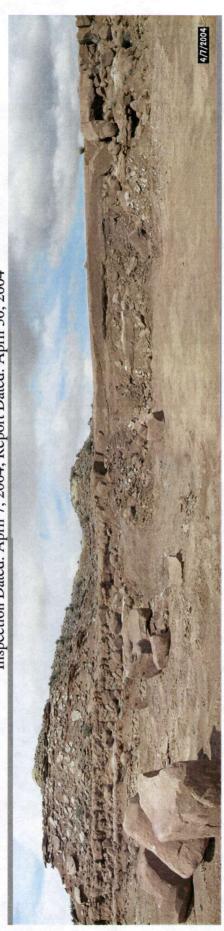
The area in which this quarry is located has about three levels or steps. The quarry is on a sort of sandstone ledge on the middle step (Photo 1). There is about one-half acre of disturbance for the quarry itself, and, at this time, there is no topsoil or vegetation.

Photo 1. Panorama of the quarry.

If the operator was to reclaim at this time, no revegetation would be required. If the quarry continues to progress toward the north, it will eventually be necessary to begin saving topsoil.

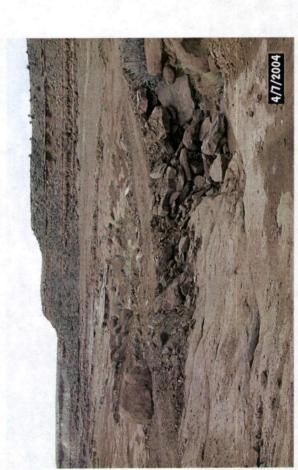
There is a 330-foot access road that appears to have been built for the quarry, and it connects to one of the somewhat non-descript roads in the area that lead to the main road to the north. At the end of the road to the mine, the operator appears to have placed boulders to restrict access to the quarry. At this

point, fill had been placed in a small drainage for the road crossing. There was no culvert, and some water had ponded on the upstream side of the fill.

Photo 2. East end of the road leading to the quarry. Note the drainage the road crosses and the large rock blocking the road.

If the access road is going to be there for very long (more than a year), a culvert should be installed where the road crosses the small drainage. This is not vital, but in case of a large storm, it could keep the road from being washed out and sediment from going off site.

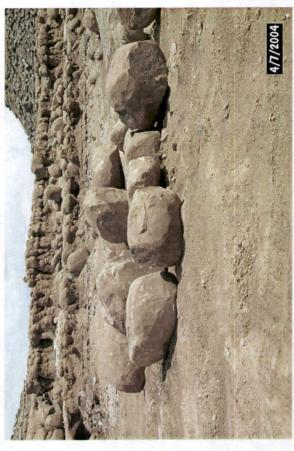
Photo 3. A stockpile at the quarry.
